Richmond Refinery LPS Bulletin – Reliability & Safety

Unloader Failure and H2S Exposure at K-1100A Compressor

Distillation & Reforming,
Richmond Refinery

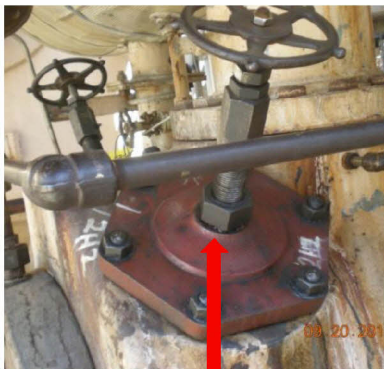
Suction valve unloader

On September 15th, 2011 at 04:38, one of the second stage crank end valve unloaders on a Crude Unit Atmospheric Column Off-Gas Compressors (K-1100A) became detached from the compressor. This caused a leak of hydrogen sulfide (H₂S) and mixed light hydrocarbons may have been released into the atmosphere.

- 1) The shop procedure and guidance from the refinery Rotating Equipment Reliability team has a torque value for the cover and not the jam nut. Machinists apply torque to the jam nut based on feel because they do not want to over torque the equipment since it is cast material.
- 2) The design of the unloaders on K-1100A allows an operator to turn the valve unloader past the position where the plate valve is closed because there is no visible indicator to advise the operator when they have reached the desired position and to stop turning the valve.

- 1) The design of the valve unloaders on K-1100A was such that there was no field indication that the unloader had reached the position where the plate valve was no longer held open. The post-incident inspection found that the valve unloader was turned past the fully closed position and that it would only take 9 ft-lbs of torque to exceed the desired position and loosen the jam nut.

- 1) Upgrade the hand operated valve unloaders on the K-1100A to eliminate the jam nut torquing issue by identifying the closed position.
- 2) Revise the procedures for compressor loading and unloading to reflect the upgraded design. The procedure should clearly define which valves are crank end and which are head end.

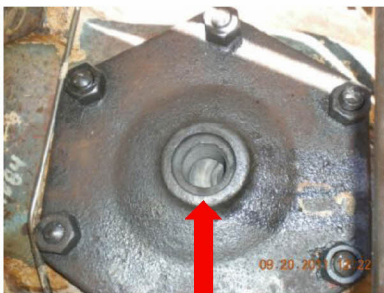
Parts inside restricting the flow.
